Failure Analysis of a Cracked UH-1 Tailboom Former, P/N 205-030-807-97

ARL-TR-3828

June 2006

**Scott Grendahl
U.S. Army Research Laboratory
Weapons and Materials Research Directorate
Aberdeen Proving Ground, MD 21005**

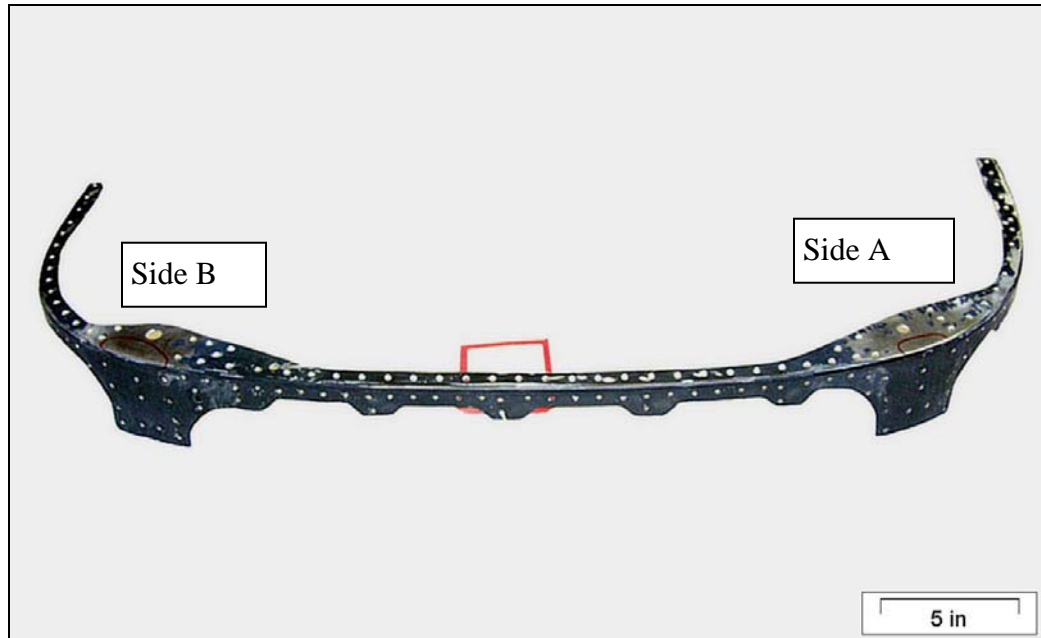
The U.S. Army Aviation and Missile Command sent the U.S. Army Research Laboratory Weapons and Material Research Directorate a UH-1 tailboom former (P/N 201030-807-97) from the U.S. Army Kwajalein Atoll facility (USAKA) in the Marshall Islands for investigation. The component was being investigated due to the presence of cracks observed near bolt hole locations on the part. This component was quality deficiency report exhibit number M24H90327. The material utilized to manufacture the former was specified to be clad 2024-T4 aluminum alloy sheet IAW QQ-A-362. QQ-A-362 is a very old cancelled specification. No copies of that specification could be recovered. It was superseded by QQ-A-250/5B, which was subsequently cancelled, and superseded by the current specification for clad 2024-T4 aluminum sheet, SAE-AMS-QQ-A-250-5. The part was characterized through nondestructive inspection, chemical analysis, optical microscopy, scanning electron microscopy, and mechanical testing. Figure 1 depicts the as-received tailboom former from USAKA.

Figure 1. As-received component UH-1 tailboom former.

- The UH-1 tailboom former exhibited cracking near both of the bolt hole locations. The crack on side A (figure 1) was a through-thickness crack propagating entirely through the 0.050-in thickness of the component. The overall crack length was 1.25 in. The crack on side B was similar, and its overall crack length was 1.3 in.

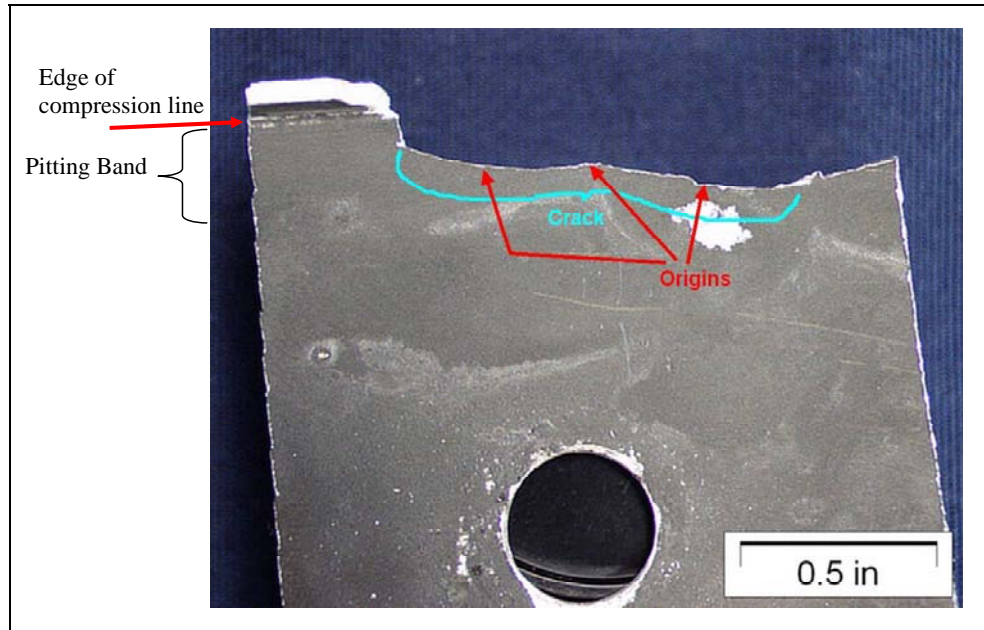
The tailboom former was inspected visually and with light optical microscopy. Two cracks were observed, one near the hole on side A, and the other near the hole on side B. The proximity of the crack to the hole was ~0.75 inches in each case. The crack on side A was opened mechanically for fractographic examination. The opened crack is shown in figure 4, with the origins labeled in red. One half of the fracture surface is shown in figure 5. This crack had three distinct origins. Two of the origins were corrosion pits initiating on the concave side. The corrosion initiation site on side A can be observed in figures 6 and 7 (figure 7 depicts a 45° tilt). There were three small corrosion pits in this area, so the initiation site was actually a region rather than a specific point. The largest of the corrosion pits appeared to be ~0.005 in deep. The

Figure 4. One half of the fracture surface of the crack on side A.

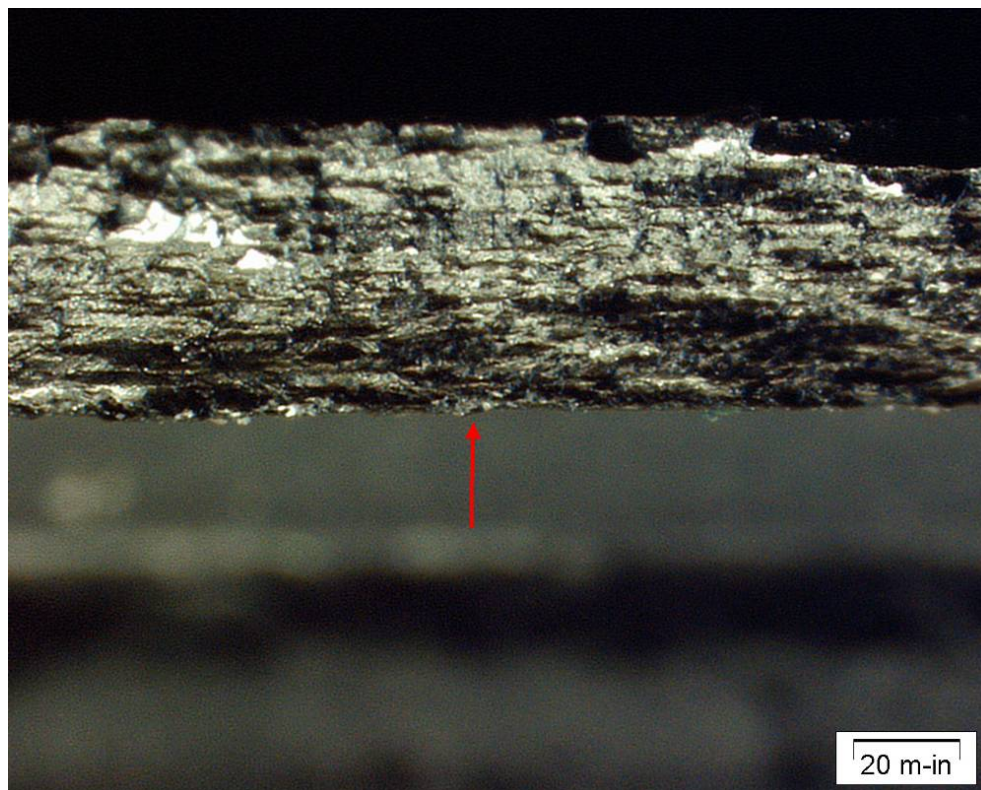
corrosion initiation site on side B can be observed in figures 8 and 9 (figure 9 depicts a 45° tilt). Crack arrest lines (beach marks) and chevron patterns were observable on the fracture surface near these origins. The third origin was fatigue initiated at a surface imperfection unrelated to corrosion, but also on the concave side of the component. This initiation site can be observed in figure 10. The crack progression spread out symmetrically from these three points to form a final crack length of 1.25 in, as observed in figure 5. It was apparent that the cracks joined together and propagated entirely through the 0.050-in thickness of the tailboom former.

Figure 8. Fractograph of the corrosion initiation site on side B.

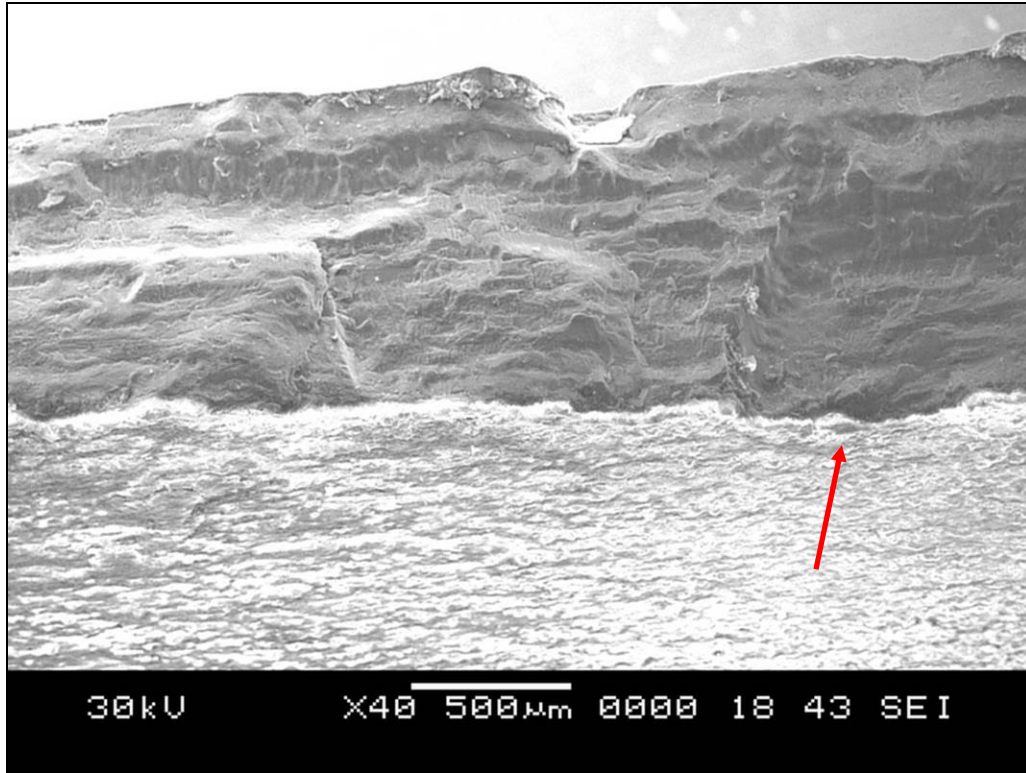
SEM, utilizing a JEOL-JSM 6460-LV, was performed to investigate the fracture surfaces in greater detail. The fracture surface of the opened crack is depicted in the electron fractograph in figure 11. The total crack length measured 1.25 in. At closer inspection, evidence of cyclic fatigue crack propagation was present (figure 12). Fatigue progression lines can easily be observed (this is the transition region at the end of the crack between transgranular fracture and ductile overload). The fracture morphology was transgranular throughout the cracked region. The origin area on side A is depicted in figure 13 and at 45° in figure 14. A higher magnification image of the large corrosion pit on side A is shown in figure 15. The origin area on side B is depicted in figure 16 and at 45° in figure 17. The third initiation site can be observed in figures 18 and 19. All the origins were on the concave side of the part.

Figure 19. SEM micrograph of the center fatigue initiation site at 45°.

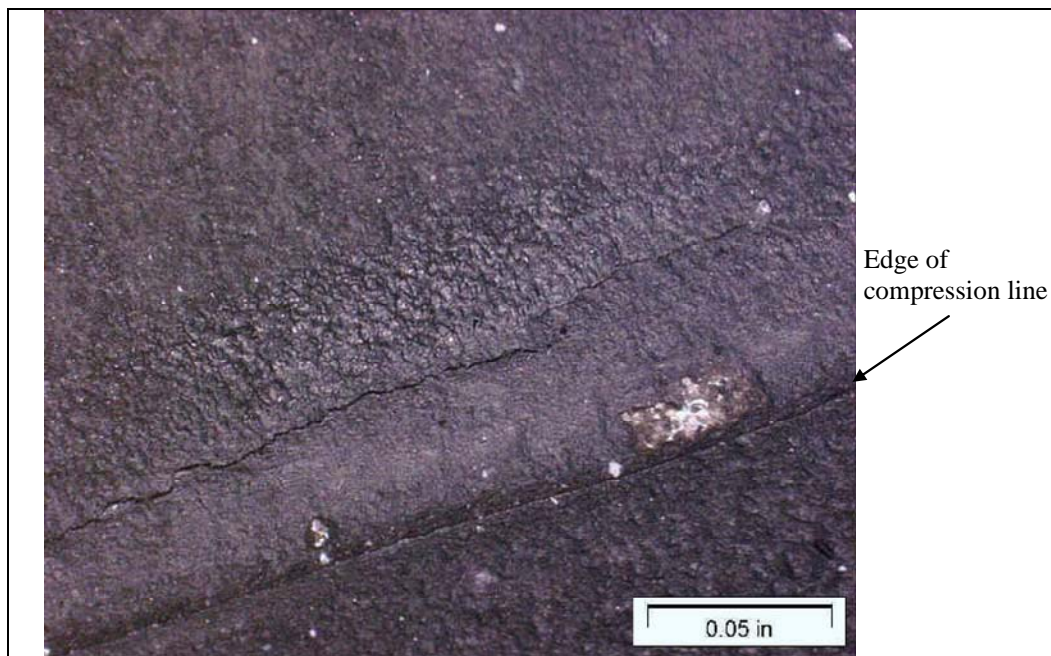
Figure 25. Exterior surface of the tailboom former coated with MIL-P-23377.

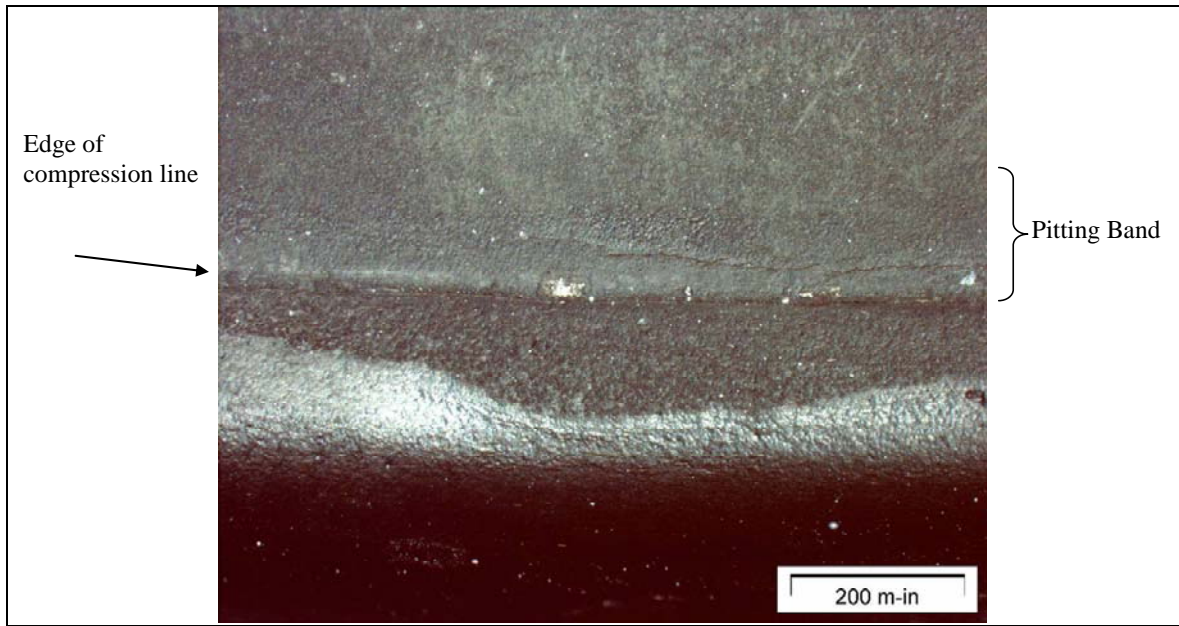
The tailboom former failed by a fatigue mechanism initiated at corrosion pits. These pits likely developed over time either from damage induced during overhaul or within the natural crevice formed by the tailboom former and its mating component in the assembly. Pits were observed both with paint covering them and inactive, and recently active and corroding. It is likely that some of the pitting corrosion was missed during overhaul and paint was reapplied over them.

Figure 26. Corrosion pitting band near edge of crevice compression line.

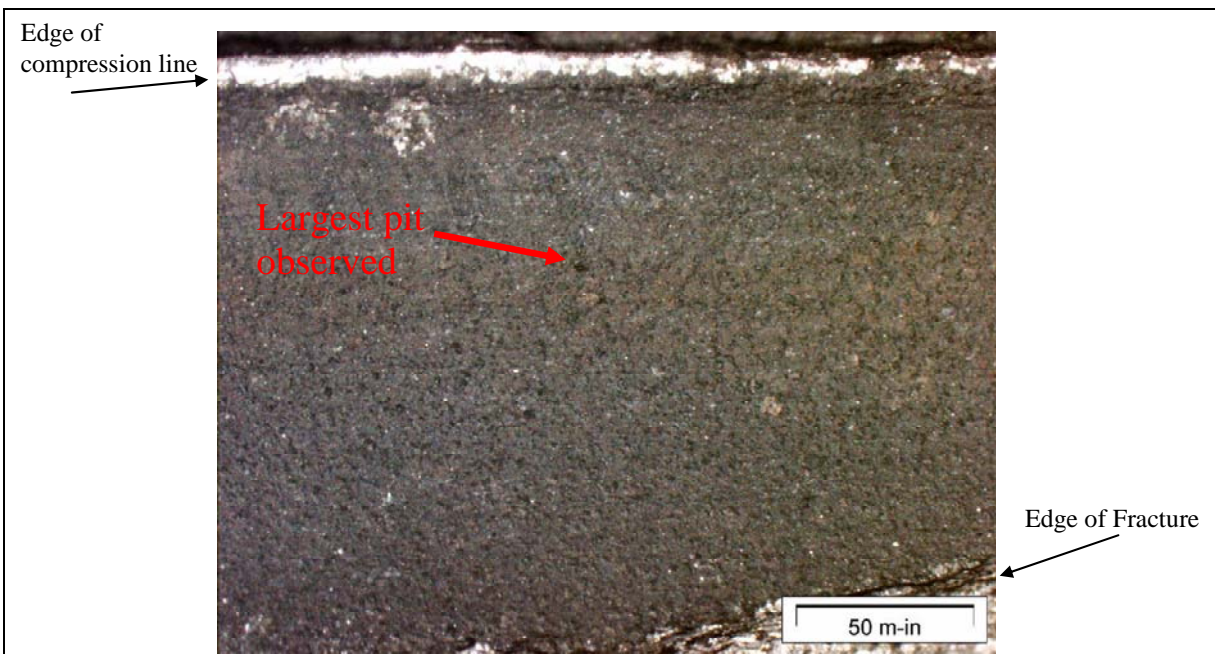
Figure 27. Pits adjacent to the edge of the fracture.

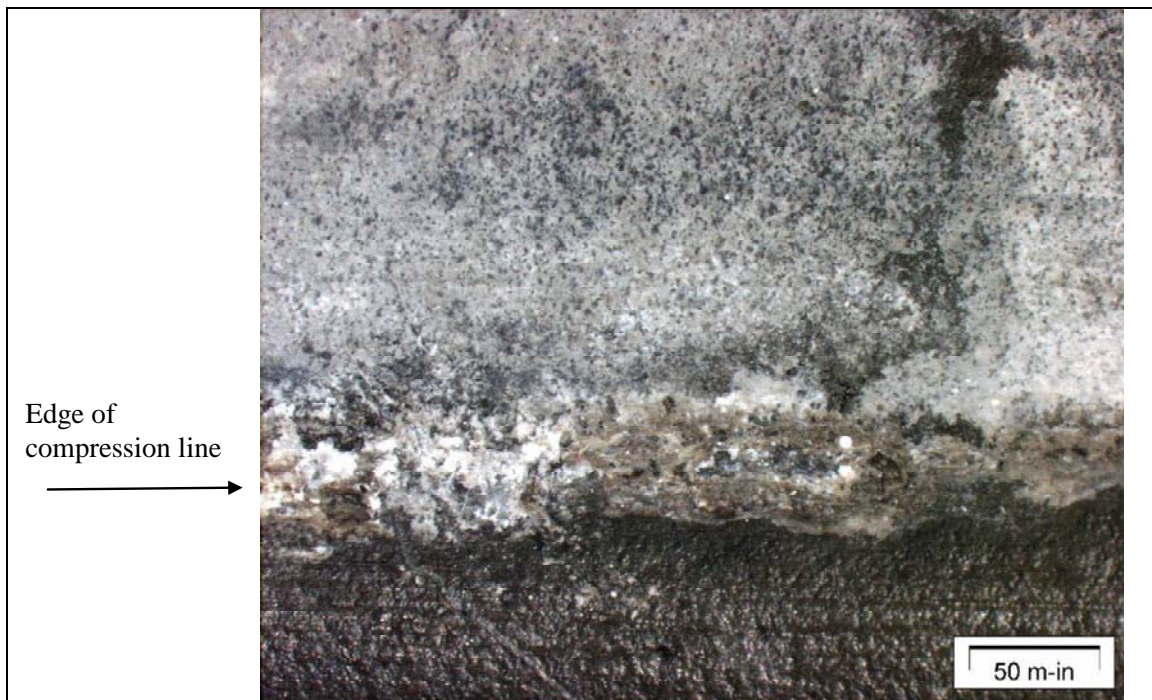
Figure 28. Pitting and corrosion product along the edge of compression line.
